AFWAL-TR-89-4004

LOW CYCLE FATIGUE OF SURFACE MOUNTED CHIP
CARRIER/PRINTED WIRING BOARD JOINTS

September 1987

Interim Report

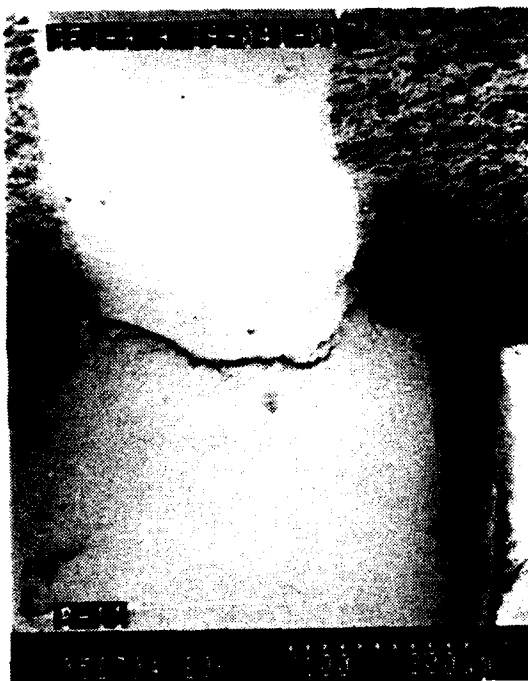
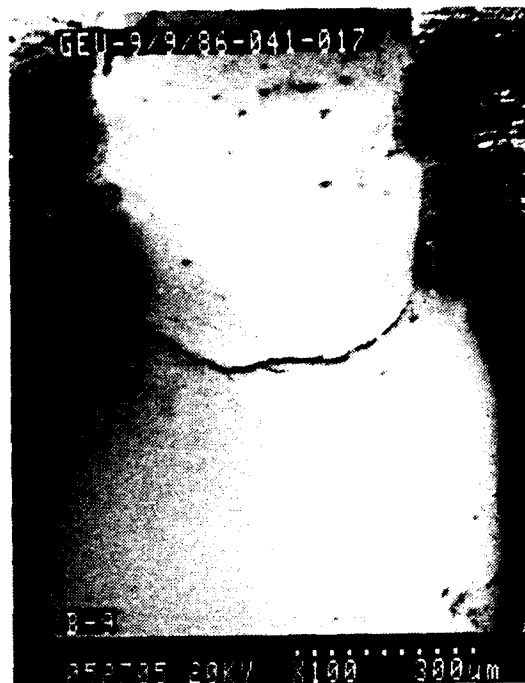
Figure 10. Fillets of joints cycled to a 60% drop in load. (a) Joint with a resistance increase of 0.3%, (b) joint with a resistance increase of 0.15%, (c) joint with a resistance increase of 0.12%, and (d) joint with a resistance increase of 0.11%.

The joints shown in Figure 10 were cycled until the load dropped by 60%. The joint of Figure 10a showed a resistance increase of 0.3%, and a crack is clearly visible. The joint of Figure 10b experienced a resistance increase of 0.15%, and a fine crack is visible. The joints of Figures 10c and 10d show the evidence of surface damage and

very fine cracks. The resistance increase was 0.12% and 0.11%, respectively.

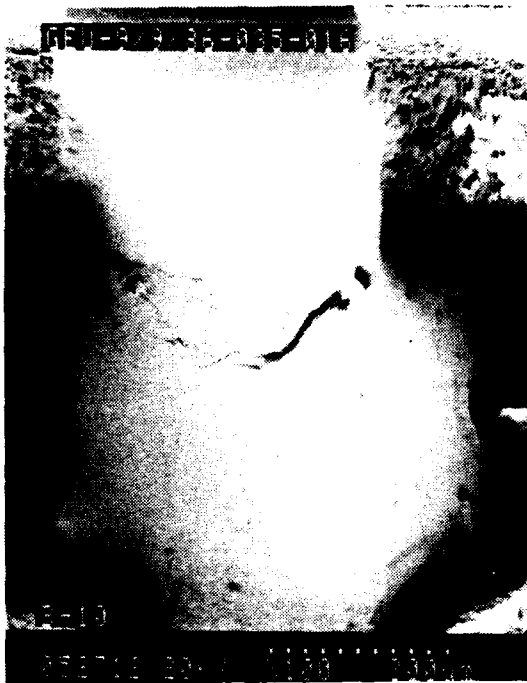
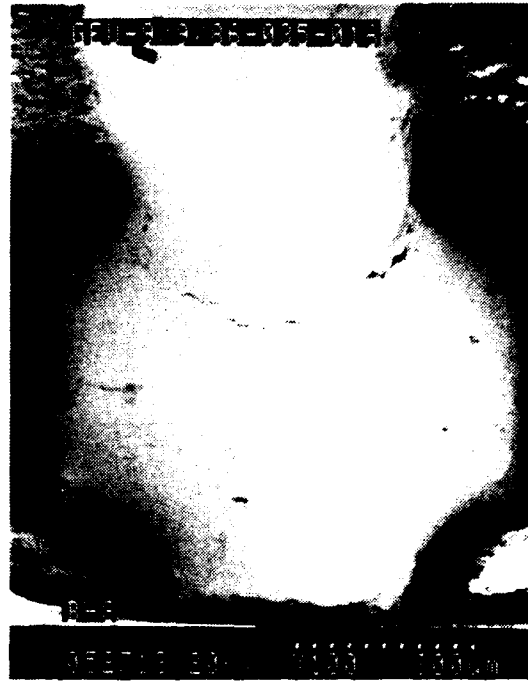
Figure 11. Fillets of joints cycled to a 74% drop in load. (a) Joint with a resistance increase of 0.54%, (b) joint with a resistance increase of 0.19%, and (c) joint with a resistance increase of 0.03%.

Figure 11 shows joints cycled to a load drop of 74%. The joint in Figure 11a exhibited a resistance increase of 0.54%, and a large crack is visible. The joint in Figure 11b exhibited a finer crack and a resistance increase of 0.19%. No crack is visible in Figure 11c, and the resistance increase was only 0.03%. As a general rule, when the resistance increase is 0.1% or greater, a crack can be observed in the joint fillet at 50-100 \times . The smallest resistance increase for which a corresponding crack in the fillet was observed was 0.09%, but the crack was not completely around the fillet.
